Aging Effects in FPGAs: an Experimental Analysis

Abdulazim Amouri*, Florent Bruguier†, Saman Kiamehr*, Pascal Benoit†, Lionel Torres† and Mehdi Tahoori*

Abstract—Modern Field Programmable Gate Arrays (FPGAs) are built using the most advanced technology nodes to meet performance and power demands. This makes them susceptible to various reliability challenges at nano-scale, and in particular to transistor aging. In this paper, an experimental analysis is made to identify the main parameters and phenomena influencing the performance degradation of FPGAs. For that purpose, a set of controlled ring-oscillator-based sensors with different frequencies and tunable activity control are implemented on a Spartan-6 FPGA. Thus, the internal switching activities (SAs) and signal probabilities (SPs) of the sensors can be varied. We performed accelerated-lifetime conditions using elevated temperatures and voltages in a controlled setting to stress the FPGA. A novel monitoring method based on measuring the electromagnetic emissions of the FPGA is used to accurately monitor the performance of the sensors before and after the stress. The experiments reveal the extent of performance degradations, th

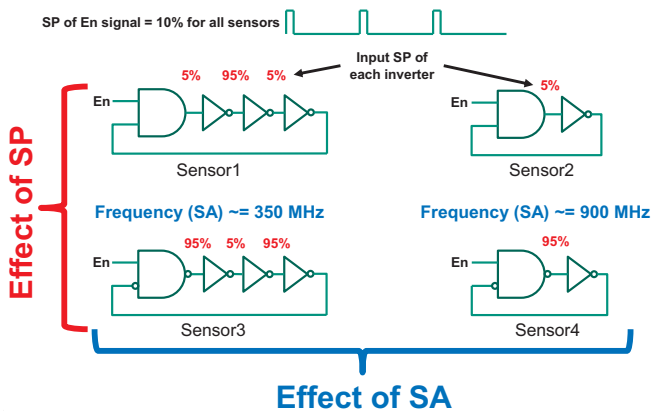
As mentioned before, the BTI mechanism is distinguished by its sensitivity to the SP, while the HCI by the sensitivity to the amount of SA. Taking that into account, a set of four controllable *Ring-Oscillator* (RO)-based sensors are used to vary the values of SPs and SAs (see Figure 1). The number of the stages in the RO can determine the generated frequency, and hence the amount of SA. Two of the sensors are utilized for this purpose; the first one (S1) with three inverter stages (reaching a frequency of ≈ 350 MHz on a Spartan-6 FPGA) and the second one (S2) with a single inverter stage (for a maximum possible frequency of ≈ 900 MHz on the same FPGA).

Figure 1. Sensor versions to vary SPs and SAs

To vary the SP of the internal sensor stages, the switching of the RO itself can be controlled. Usually, all the internal stages of the RO have a fixed input SP of 50% because the inverters toggle continuously between logic-0 and logic-1. Adding an external enable signal (En) to enable/disable the switching of the RO can change the input SPs of all the inverters accordingly. Based on that, an enable signal is added to both S1 and S2 to specify their internal SPs. A clock signal with a duty cycle of 10% is fed to this enable signal, which set the internal SPs of S1 to 5%, 95% and 5% respectively as shown in Figure 2, and the internal SP of S2 to 5%. It should be noted that this enable signal is very low frequency (i.e., 10 kHz) compared to the frequency of RO such that it does not interfere with the functionality of RO. In order to get the effect of the reverse combinations of input SPs, two other sensors are used; S3 as a counterpart to S1 with internal SPs of 95%, 5% and 95%, and S4 as a counterpart to S2 with input SP of 95% as shown in Figure 1.

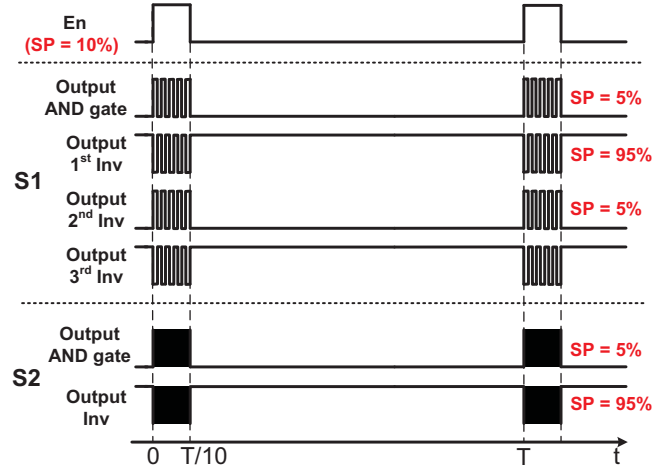
Figure 2. The internal SPs for sensors S1 and S2

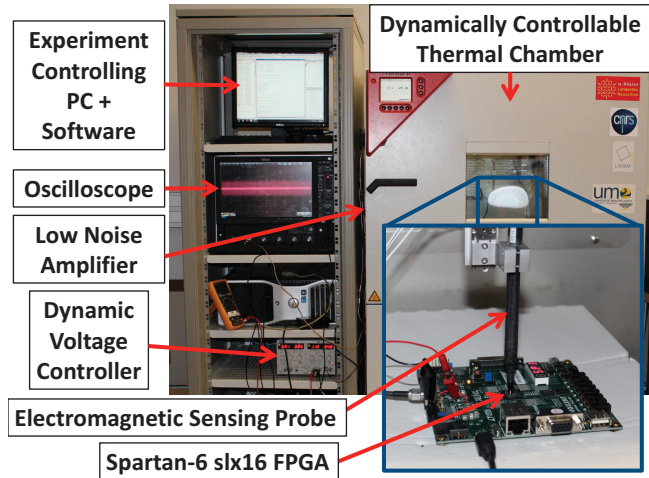
In this section, we describe our experimental setup, depicted in Figure 3, for both applying the accelerated lifetime conditions and monitoring the performance of the sensors before and after the stress. This is followed by an illustration for the schedule in which the experiment is applied.

In our setup, to eliminate the on-board sources of variation, in addition to applying the accelerated lifetime conditions, the Nexys board was modified to have a direct access to the FPGA core voltage. The FPGA board is then supplied using an external high-precision dynamic voltage controller and the temperature is regulated using a dynamically controllable thermal chamber (See Figure 3). For monitoring the performance of the sensors before and after the stress, an *Electro-Magnetic* (EM)

Figure 3. Experimental setup

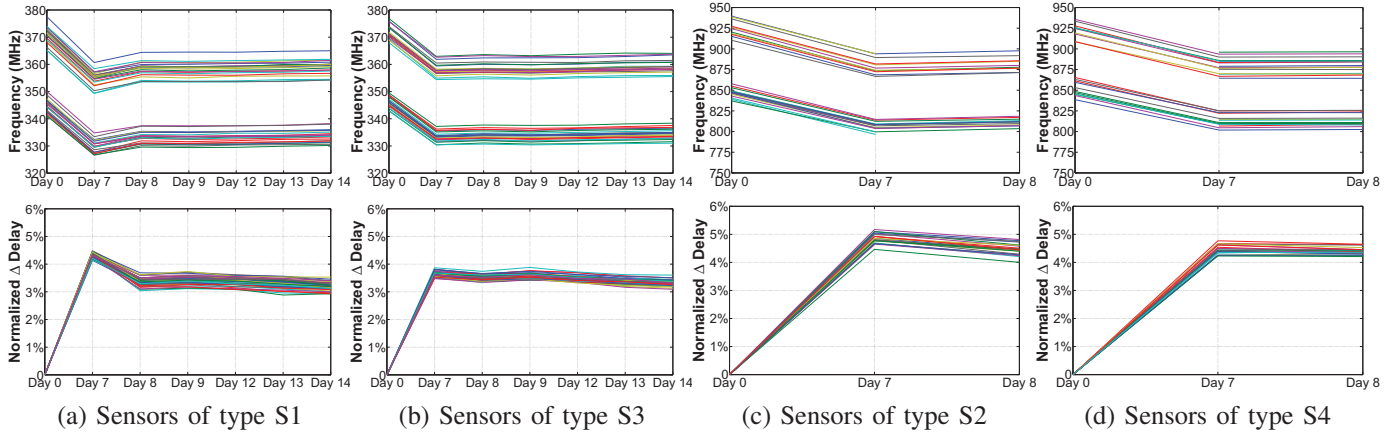
The frequency changes of each type of sensors (40 sensors from each type) during the experiment period are depicted in Figure 4. Unfortunately, for the sensors of type S4, the measurement data got corrupted after Day 8. Actually it is because post-processing is more complex with our equipment with such frequencies (which means it requires much time and visual analysis). However, the trend was the same after 2 and 3 days on a subset of points. Therefore, for both S2 and S4 sensors the results are shown only till Day 8 to allow the comparison between these two types.

As can be observed in Figure 4, there are two distinguished groups of frequencies appearing for each sensor type. These are the result of mapping the sensors to different CLBs. Actually, as discussed in Section II-B, each CLB in Spartan-6 FPGA contains two type of slices: either SliceX with SliceL or SliceX with SliceM. Although only SliceXs are chosen to map the sensors, the results show that the sensors mapped to the CLBs that contain SliceM beside SliceX are slower than those mapped to the CLBs that contain SliceL beside SliceX by about 7 to 9%. This is inline with the previous results of [9]. The other observation is that there is a clear performance variation between the sensors of each type.

Although the previous observations are interesting, the main observation however in Figure 4 is the relatively large performance degradation after the stress for all the sensors. This degradation reaches to 5.17% for some sensors of type S2 (see Figure 4).

Figure 4. The frequency change and the corresponding normalized Δ Delay change for each sensor (40 sensors from each type, each line color represents a single sensor)

SliceL or SliceM. The sensors mapped to the CLBs that contain SliceL are faster than those mapped to the CLBs that contain SliceM by about 7 - 9% (see Figure 4). However, there is no noticeable difference between the aging of both. Again, this is due to the limited effect of frequency change on aging for this technology. Since only HCI, and not BTI, is affected by frequency changes, it can be concluded that the HCI effect in this technology node is less than the BTI effect.
